Some More Modifications

30m QRSS beacon: QRV: more modifications

Written by Hans Summers
 Monday, 25 May 2009 02:55 -

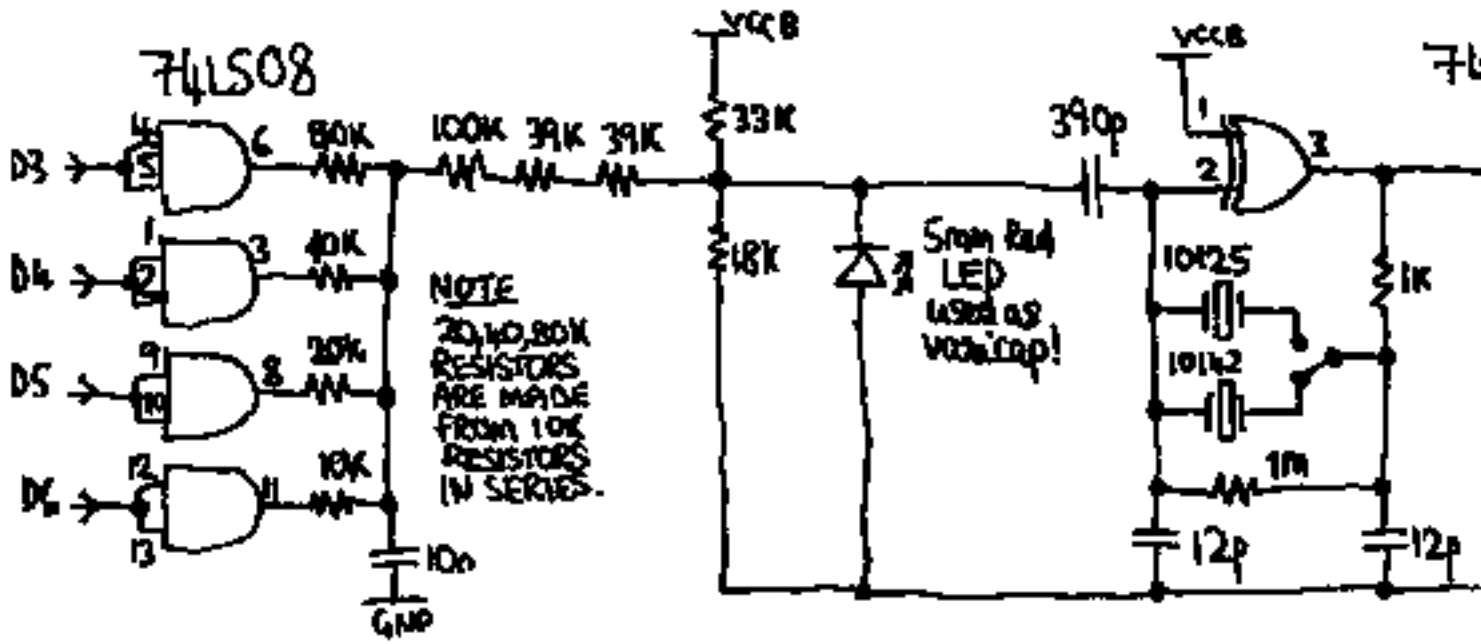
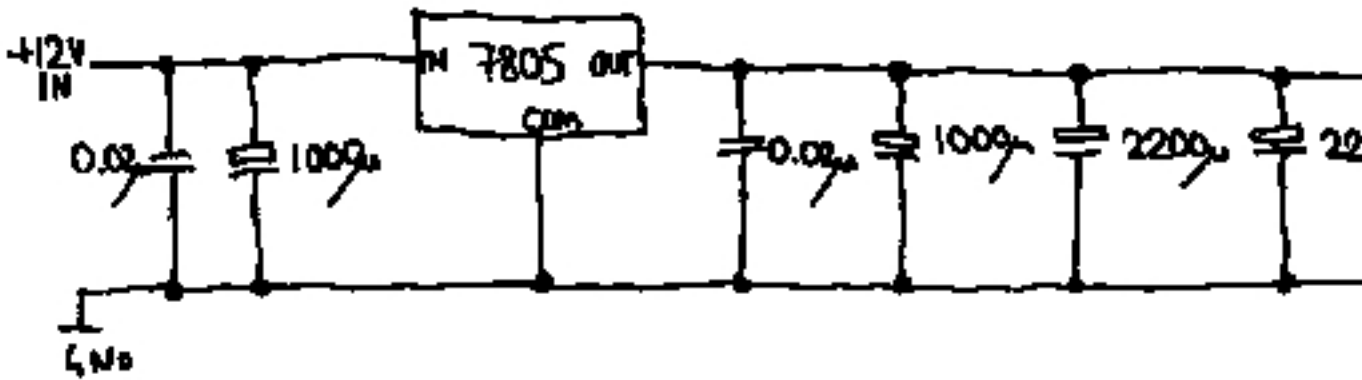
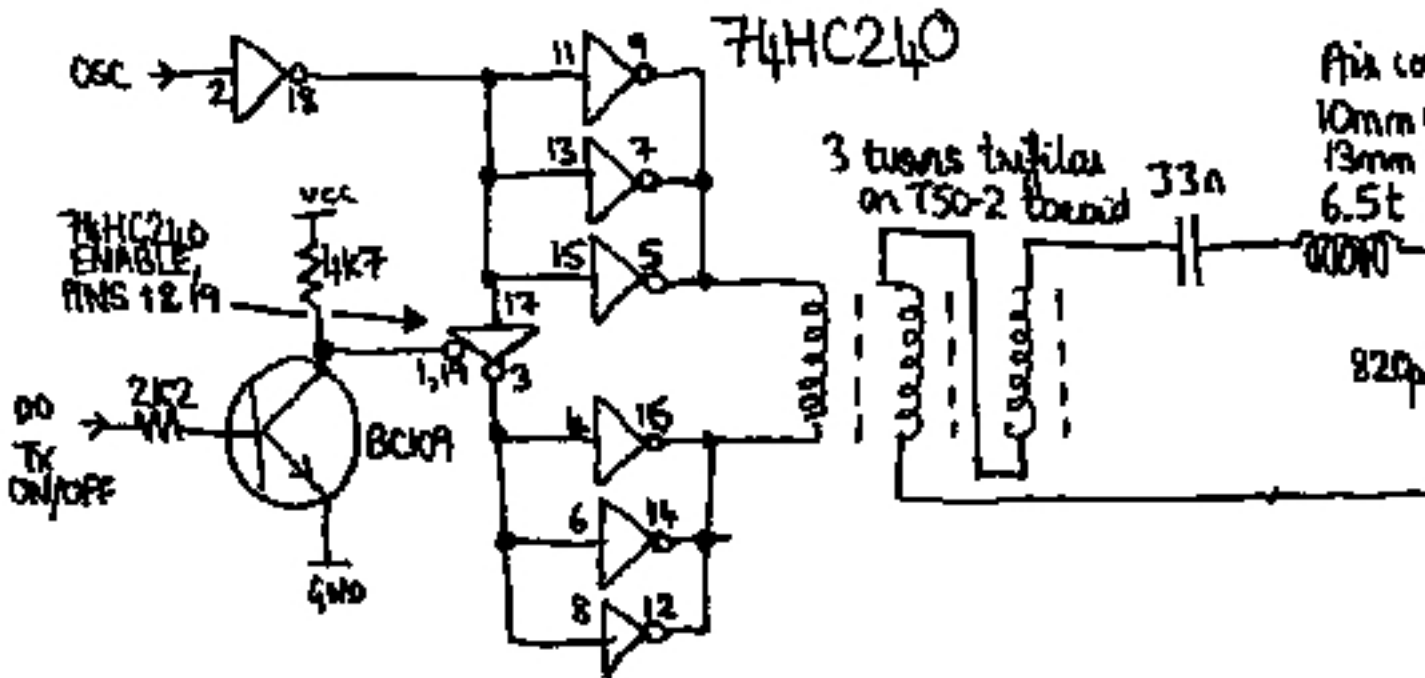
I suspect that the problem with chirp is caused by the single gate of the 74HC86 chip which is being used as oscillator, being connected directly to 74HC240 power amplifier. Any tiny change in capacitance or loading of the 74HC240 input (i.e. when it heats up) will be able to pull the crystal frequency and cause the observed chirp. So I made 3 further modifications (less major than the last batch):

This is the new circuit of the oscillator section, incorporating all the changes since the original design where the oscillator inverter was one of the gates on the 74HC240 (**loads** of chirp!).

First, I utilised the other 3 XOR gates in the 74HC86 as buffers, to isolate the oscillator inverter from the power amplifier. I can't actually think why I didn't do this in the first place, the gates aren't required for anything else.

Secondly, I increased the series resistor (by two 39K resistors in series with the existing 100K) in the frequency shift resistor network that controls the varicap (5mm red LED). This will make the shift voltage have less magnitude. I hope that the new range is approximately the same as it was originally prior to the installation of the 74LS08 buffers, and with the full linearity restored.

Finally, I have piled in a few more capacitors around the 5V voltage regulator which supplies the oscillator. I am a lifelong believer in the principle that you can **never** have too many capacitors in a power supply.
