### 30m QRSS beacon: QRV: even more changes

Written by Hans Summers  
Monday, 25 May 2009 03:02 -

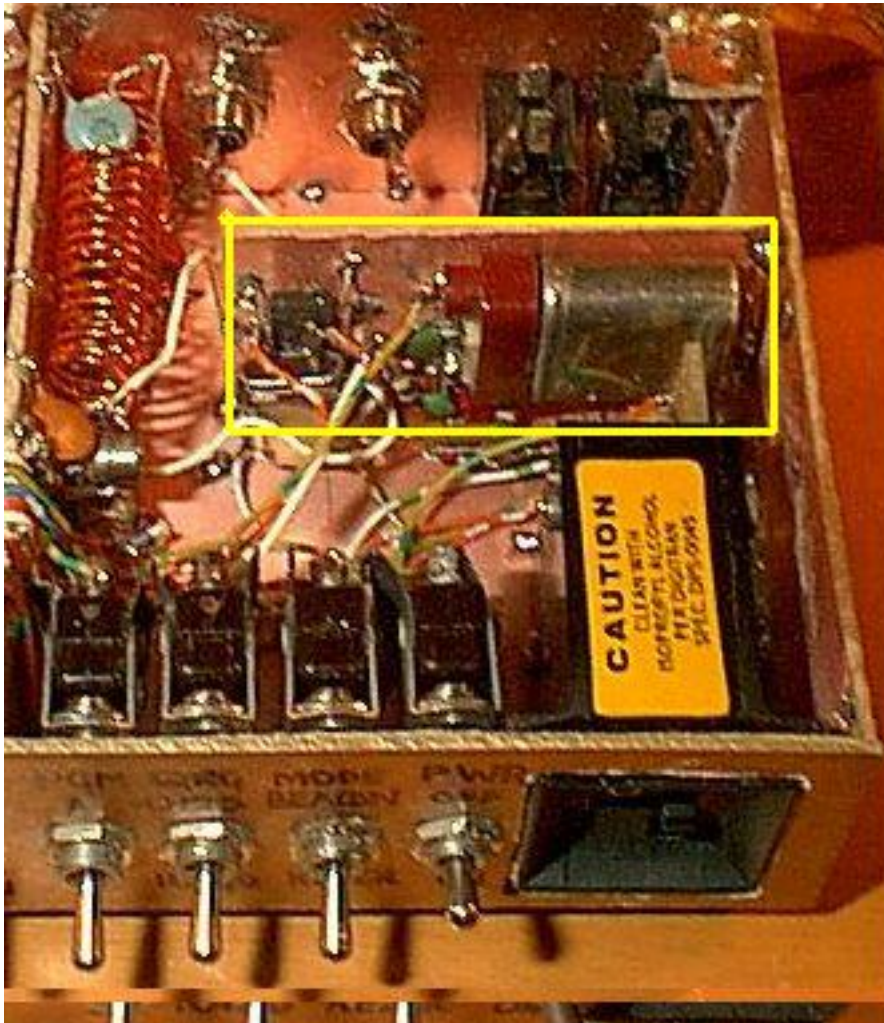
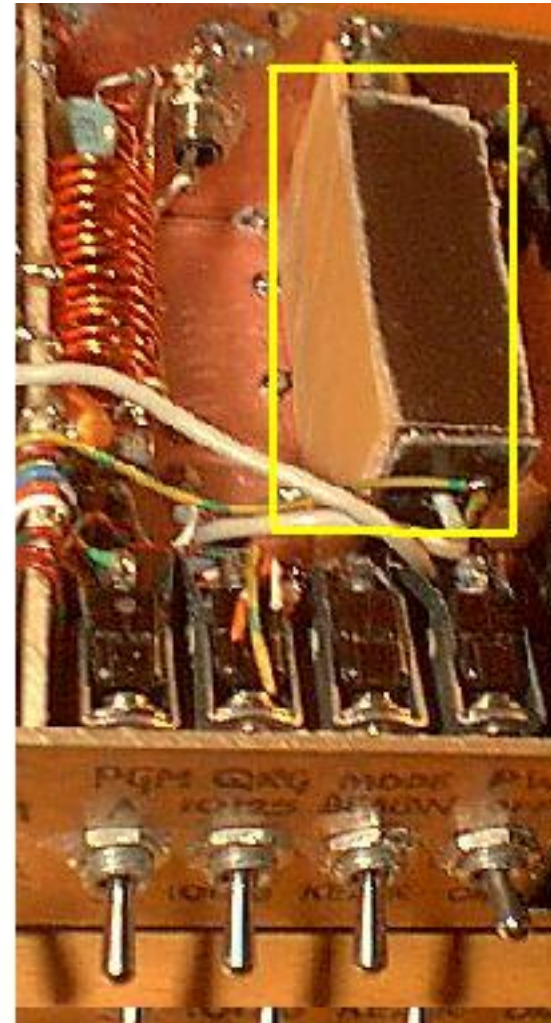
Yet one more attempt to remove the troublesome chirp and stabilise the frequency! Since the oscillator chip was right next to the output pi-network I decided to try moving it further away, and putting it in a screened box made from single-sided PCB stock. The picture shows the oscillator board, before and after. Screened cable takes the oscillator output to the pa, and brings in the frequency control voltage.

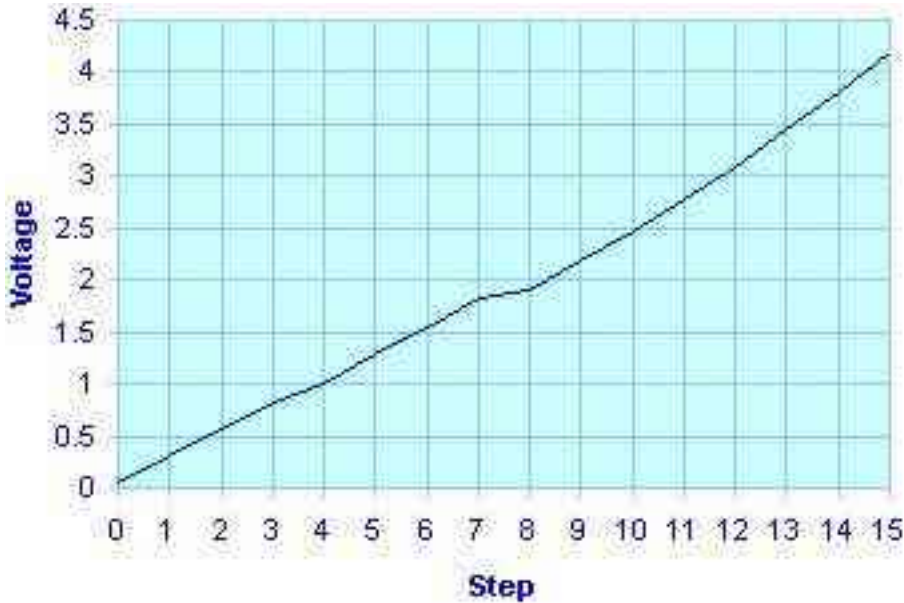
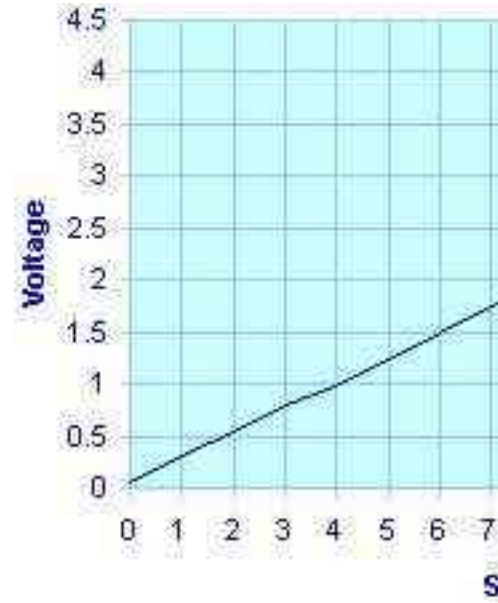
I ended up with 3 parallel resistors to the 10K resistor: values 220K, 470K and 560K. The combined value of the added parallel resistance is therefore 118K. The chart below shows the measured voltage before (left) and after (right) the corrective resistors were added. You can see that the problem with the curve at step 7 - 8 is gone. The line still isn't completely perfectly straight now I have measured it in detail, but it will be good enough to remove the observed discontinuity on the screenshots.

Next, I attempted to linearise the frequency shift (see the same-frequency 7'th and 8'th steps on the screenshots above). The lack of shift occurs when the shift changes from step 7 to 8. Therefore it is due to the 10K resistor in the resistor network being slightly off-value.

To correct the abnormality I experimented with several different value resistors in parallel with it (not being able to find easily a sufficiently high-valued preset potentiometer in the junk box). The

voltage at the output of the resistor network was measured to 2 decimal places on my DVM (at the junction of the 10K, 20K, 40K and 80K resistors).
